Inappropriate sensing events revealing electrocautery-induced implantable cardioverter–defibrillator lead failure

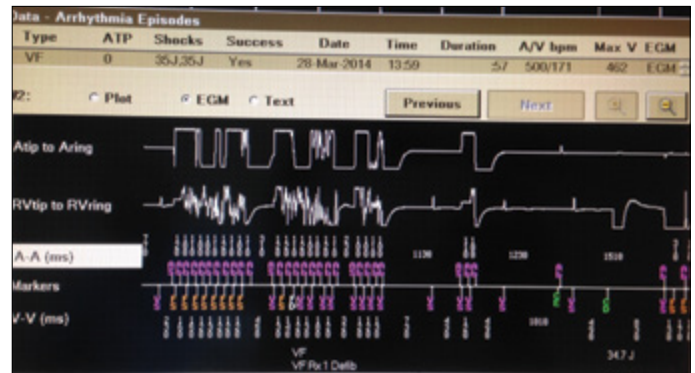
Figure 1. ECG monitoring showed electrocautery-induced electromagnetic interference and inappropriate 35J shock.

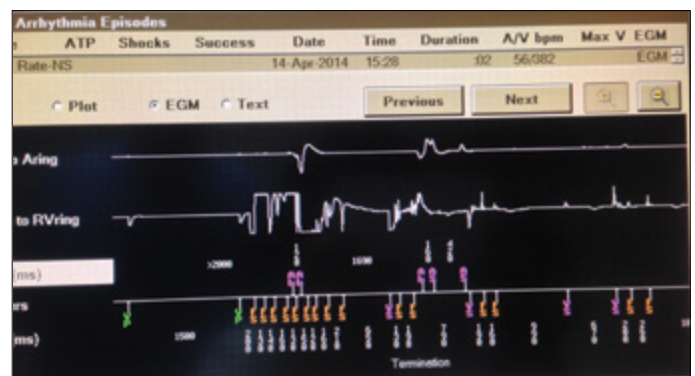
Figure 2. Postoperatively, inappropriate senses were monitored, which were concordant with lead failure.

Despite the advances in ICD technology, electrocautery, especially when used close to the device, can still lead to lead failure, which might necessitate intervention. Thus, we still recommend routine postprocedural interrogation of the device.
