## Late migration of abandoned ventricular pacemaker lead following failed traction

Remzi Karaoğuz, Timuçin Altın, A. Rüçhan Akar\*

From Departments of Cardiology and \*Cardiovascular Surgery, University of Ankara School of Medicine, Ankara, Turkey

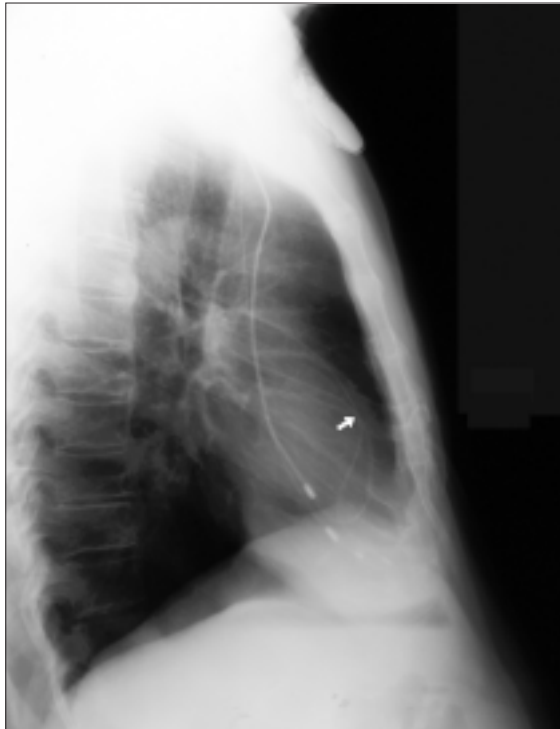
A chest X-ray on admission revealed deformed ventricular pacing lead tip located at the right ventricular apex, but the body of the lead migrated into the pulmonary artery (Fig. 1). Two-dimensional transthoracic echocardiography confirmed migration of the lead looping at the level of pulmonary artery bifurcation (Fig. 2). At inspection during surgery tricuspid chordal disrupti-

**Figure 1.** Lateral chest X-ray demonstrating migration of abandoned and deformed ventricular pacing lead into the pulmonary artery

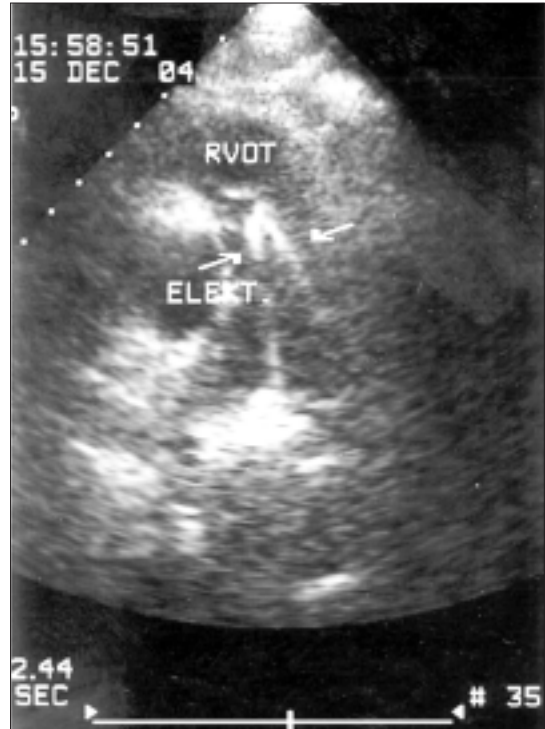
**Figure 2.** Two-dimensional transthoracic echocardiography parasternal view: the position of the electrode is indicated by arrow

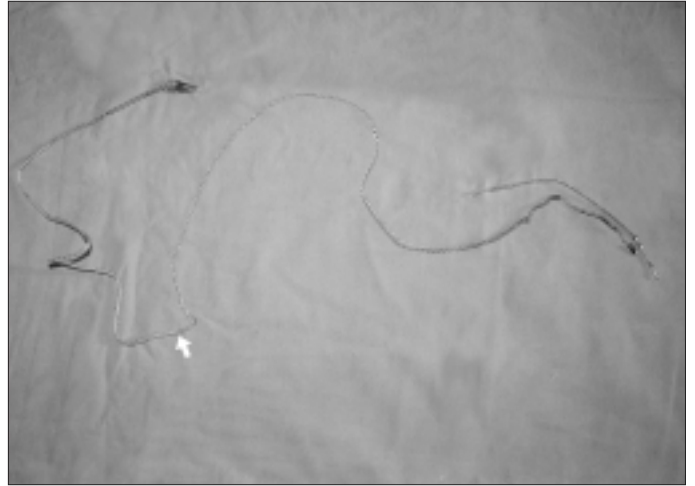
on and insulator breakage at the level of right atrium were confirmed. Lead extraction was achieved under complete cardiopulmonary bypass and beating heart. Chordal disruption caused by ventricular lead was repaired. The postoperative course was uneventful. Because of entrapment of the distal electrode tip at the right ventricular apex, previous transvenous manual traction of the lead resulted in permanent conductor material stretching and insulator material breakage (Fig. 3).

**Figure 3. The extracted lead illustrating insulator material breakage (arrow) and conductor material stretching**
