Pseudoaneurysm of the mitral-aortic intervalvular fibrosa and complementary role of 3D transesophageal echocardiographic imaging

Rupture of posterior chordae following percutaneous mitral balloon valvuloplasty for rheumatic mitral stenosis

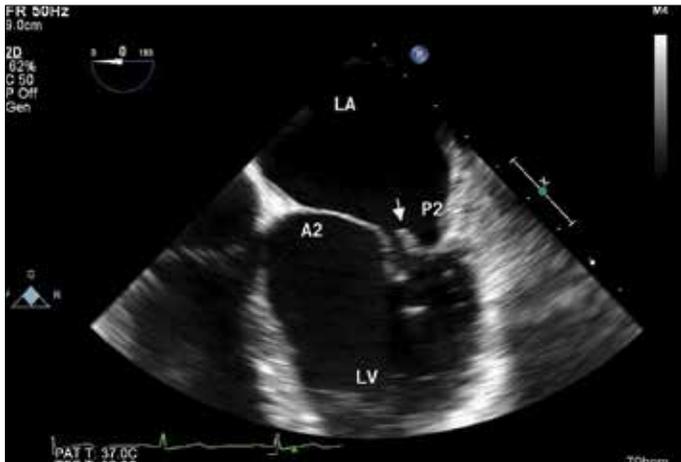
Figure 2. Two-dimensional transesophageal echocardiography, midesophageal four chamber view illustrating rupture of chordae (arrow) at the middle segment (P2 scallop) of posterior mitral leaflet
LA - left atrium, LV - left ventricle

corresponding video/movie images at www.anakarder.com). To clarify mechanism of regurgitation, we performed transesophageal echocardiography (TEE). Two-dimensional TEE demonstrated rupture of chordae on the posterior mitral leaflet (Fig. 2, Video 2. See corresponding video/movie images at www.anakarder.com). Three-dimensional TEE confirmed rupture of chordae at P2 scallop of posterior mitral leaflet (Fig. 3, Video 3. See corresponding video/movie images at www.anakarder.com). She was referred to surgery for mitral valve replacement.
