Myocardial blushing during coronary angiography due to high pressure applied by an inexperienced operator

Right ventricular lipoma

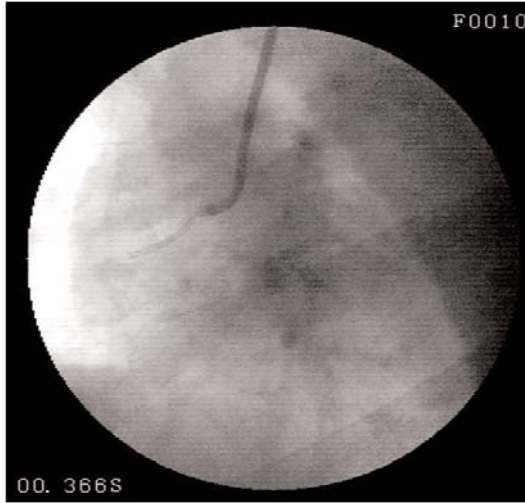
Figure 2. A prematurely displaced stent is seen proximal to the right coronary artery

The stent displacements are potential complications of intracoronary stent implantation. In the literature, we could not find a report about successful reimplantation of prematurely displaced stents in coronary arteries by methods other than previously defined conventional methods.

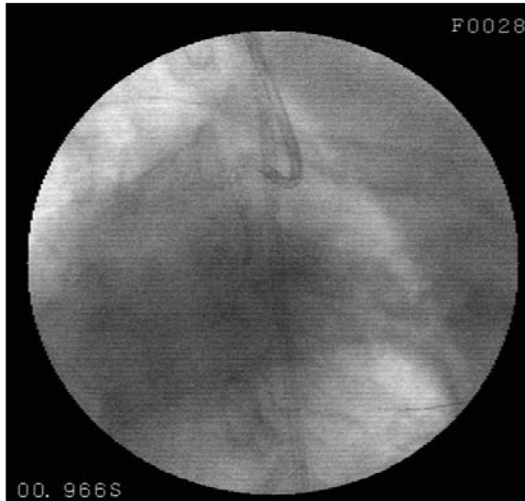
Figure 3. Pushing the stent with the tip of the balloon to negotiate the lesion

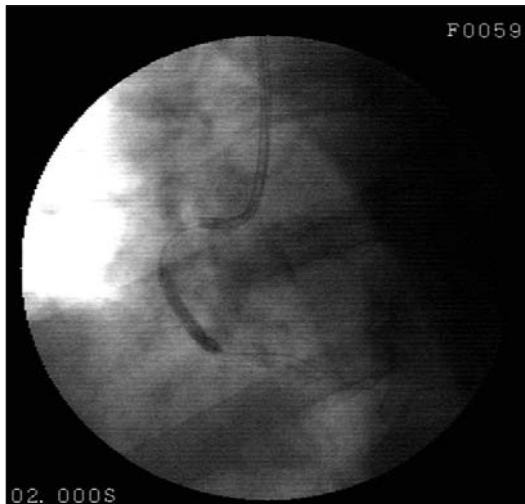
Figure 4. Deployment of stent with its original balloon

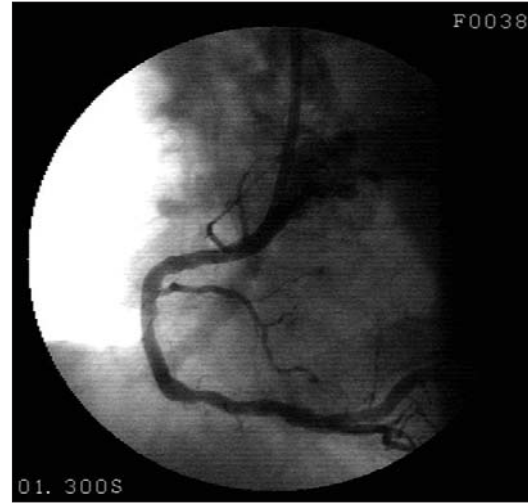
Figure 5. Final appearance of right coronary artery after deployment of the stent in the target lesion

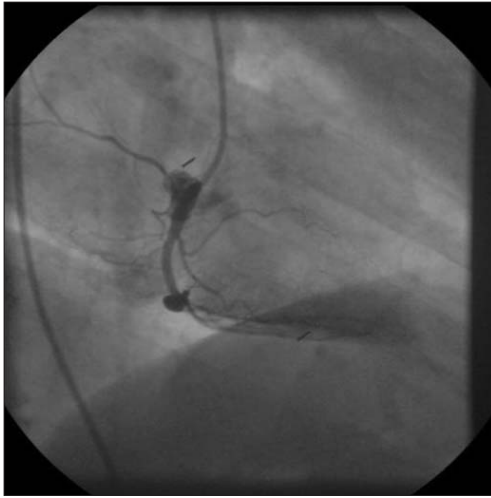
Figure 1. Right anterior oblique view of right coronary artery

A 65-year-old male patient suffering from typical anginal chest pain underwent coronary angiography. A novice resident was performing the procedure under the control of an experienced supervisor invasive cardiologist. The left coronary system was successfully visualized. However, the inexperienced operator applied excessive pressure during contrast injection. The myocardium adjacent to the right coronary artery was blushed (Ellis grade II). The blushing persisted for several minutes with patent coronary flow and without any evidence of coronary dissection (Fig 1, 2). The follow-up period after coronary angiography was uneventful.

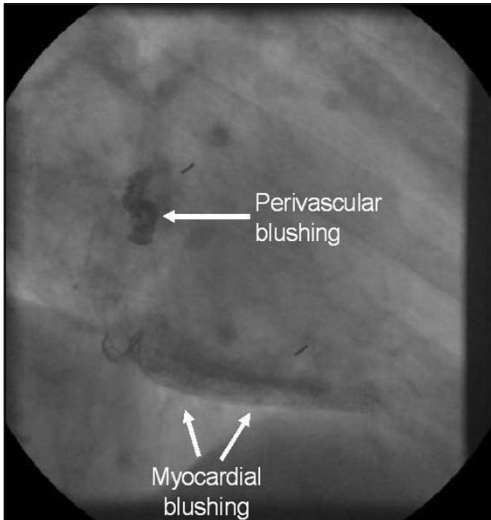
Figure 2. Myocardial and perivascular blushing are seen in fluoroscopic view at right anterior oblique position

It is advised to inject contrast volume at a rate of 7 ml at 2.1 ml/sec for the left, and 4.8 ml at 1.7 ml/sec for the right coronary arteries. It was suggested to train the fellows for adjusting the delivery rate and duration of manual contrast to match the observed filling pattern of the particular vessel being injected. In conclusion; during the training period of novice fellows injection techniques and skills should closely be supervised for injection volume and pressure.

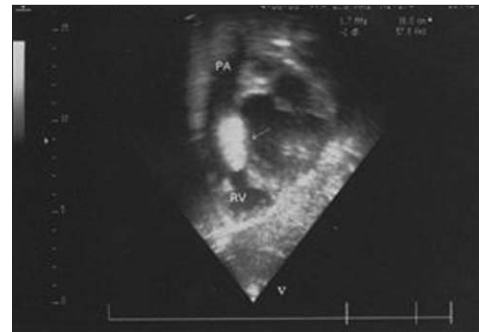
Figure 1. Transthoracic echocardiogram, demonstrating a large mass in the interventricular septum lining toward the right ventricular outflow tract

Previously healthy 11-year-old male was noted to have a heart murmur during routine physical examination. Transthoracic echocardiogram showed a mass in size of 2x3 cm in the interventricular septum lining toward the right ventricular outflow tract (Fig. 1). Cardiac magnetic resonance imaging (MRI) demonstrated a high signal intensity of the mass on the T1 and T2 black blood weighted image, with the signal intensity being reduced markedly on the fat suppression technique (Fig. 2). The mass was diagnosed as cardiac lipoma without using any invasive technique. Since the patient was asymptomatic and there was no arrhythmia and right ventricular outflow obstruction, we decided to observe him clinically. During one year of follow-up he had not any untoward event.

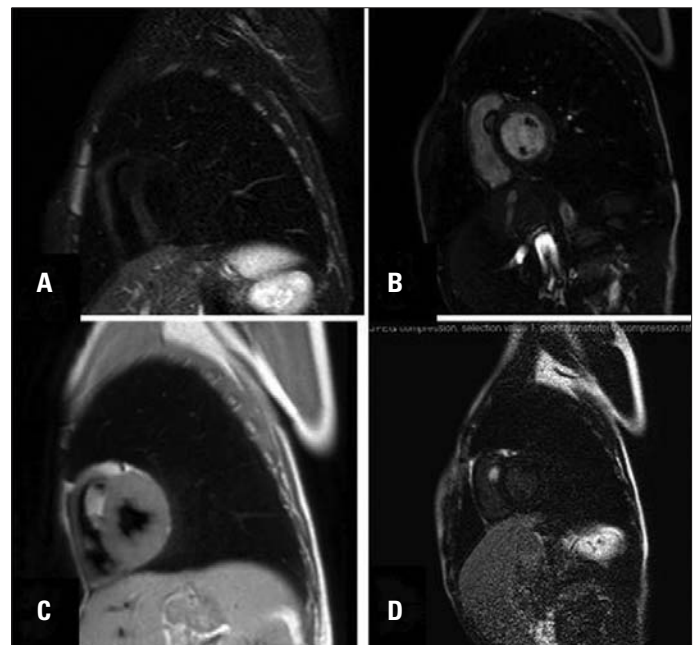
Figure 2. Magnetic resonance imaging of right ventricular lipoma

A - T2 weighted STIR
B - T2 weighted Black blood TSE
C - T1 weighted Black blood TSE
D - post contrast inversion recovery turbo field echo
