Giant right atrial thrombi associated with permanent hemodialysis catheter in a young patient: 3-dimensional echocardiography views

Thrombosis is a possible complication of central venous catheters utilized for hemodialysis. We report the case of a 25-year-old man with a previous chronic vascular hemodialysis catheter who was referred for routine echocardiogram due to persistent fever. The rest of the physical examination was unremarkable. Electrocardiography showed normal sinus rhythm. We demonstrated the presence of a 37x36 mm rounded mass and pending of the free wall of the right atrium with normal ejection fraction [Video 1, Fig. 1 (2D images), Video 2, Fig. 2 (3-dimensional echocardiography images)]. See corresponding video/movie images at www.anakarder.com]. Transesophageal study confirmed the giant

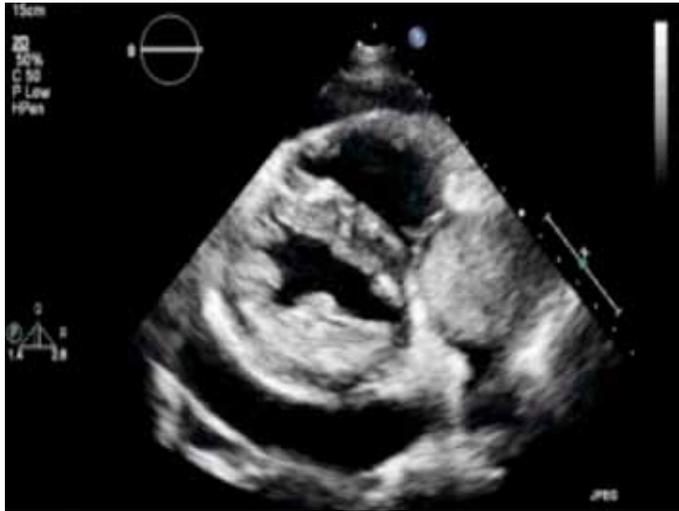
Figure 1. Two-dimensional echocardiography image of a giant and round thrombi in the right atrium

Video 1: Two-dimensional echocardiography image of a giant and round thrombi in the right atrium

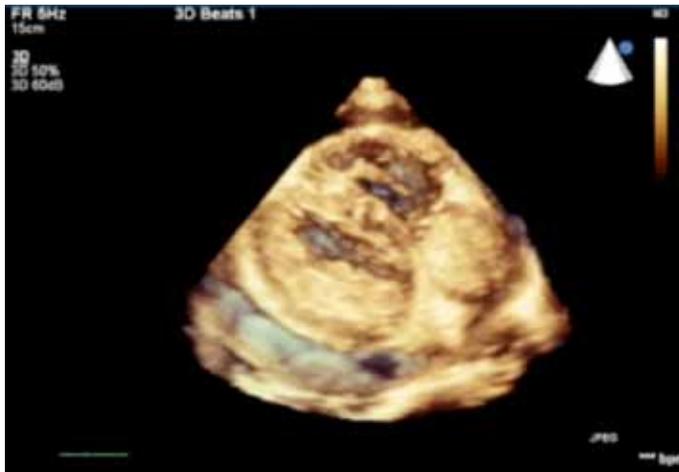
Figure 2. Three-dimensional echocardiography image of a rounded and giant mass in the right atrium

Video 2: Three-dimensional echocardiography image of a rounded and giant mass in the right atrium

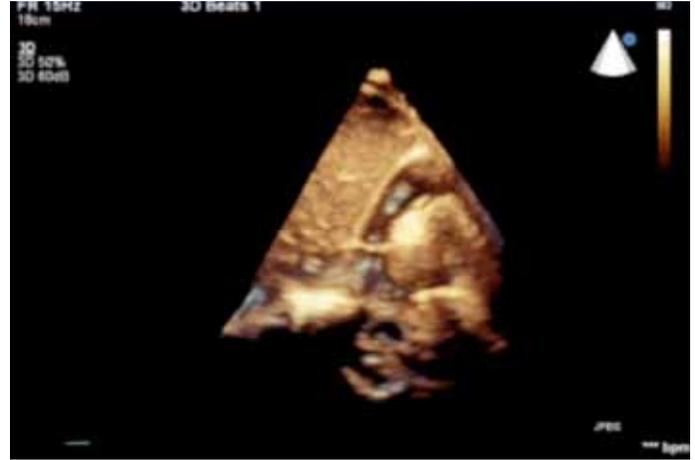
Figure 3. Three-dimensional echocardiography image of a point of the mass attachment at the right atrial free wall

Video 4: Three-dimensional echocardiography image of a point of the mass attachment at the right atrial free wall
