Incidentally diagnosed pseudoaneurysm of mitral-aortic intervalvular fibrosa

3D echocardiographic evaluation of ruptured pseudoaneurysm of the mitral-aortic intervalvular fibrosa

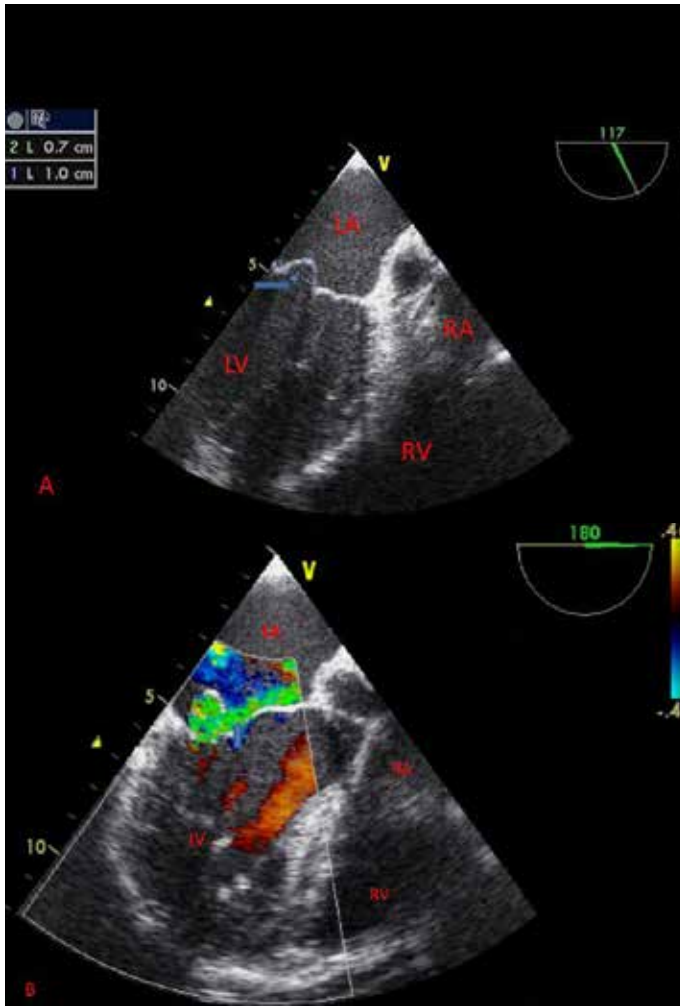
Figure 1. Transesophageal 2-chamber echocardiographic view of an aneurysm of the mitral posterior leaflet (A) and color-flow Doppler image demonstrating a severe mitral regurgitation (B)

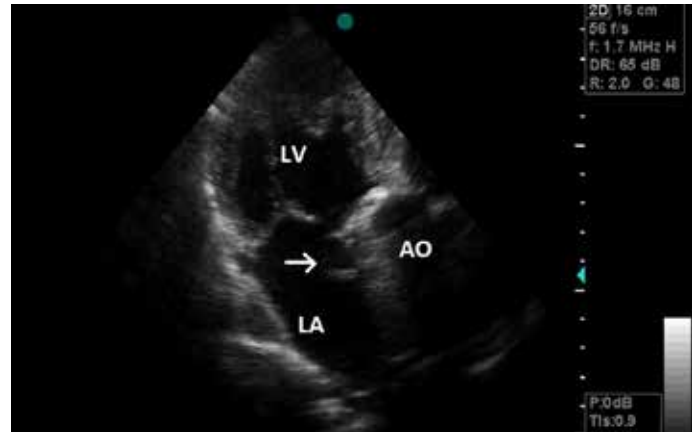
Figure 1. Transthoracic echocardiography views showing echolucent area adjacent to the aortic valve (arrow)

A 77-year-old man with mechanical aortic valve replacement due to aortic stenosis underwent transthoracic echocardiography (TTE) before non-cardiac surgery. TTE revealed an echolucent area adjacent to aortic valve, raising suspicion of a P-MAIVF (Fig.1, Video 1. See corresponding video/movie images at www.anakarder.com). He had no chest pain or dyspnea and any sign of infective endocarditis or prosthetic valve dysfunction. Transesophageal echocardiography (TEE) showed an echolucent area measuring 15 mm in its widest dimension, which was communicating with left ventricular outflow tract (LVOT). This cavity was

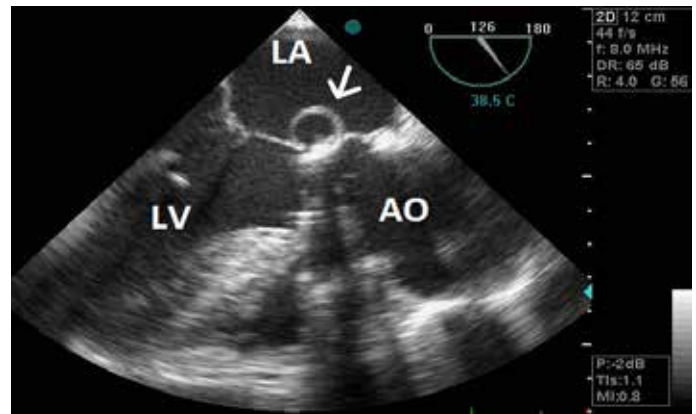
Figure 2. Transesophageal echocardiography views showing a pseudoaneurysm in the mitral-aortic intervalvular fibrosa (arrow)

highly mobile and bulging into left atrium during systole and collapsing during diastole. Doppler examination revealed blood flow into cavity during systole and flow into LVOT during diastole (Fig. 2, Video 2-3. See corresponding video/movie images at www.anakarder.com). We confirmed P-MAIVF with cardiac multislice computed tomography (Fig. 3). There was no fistulous communication to left atrium or aorta. High-risk features for progression of P-MAIVF and development of complications are active endocarditis, P-MAIVF >3 cm, bicuspid aortic valve, aortic regurgitation, presence of fistula to cardiac chamber or aorta, thrombus in P-MAIVF, compression of adjacent structures coronary or pulmonary artery. Because our patient had none of above features and because of his advanced age, we managed our patient with conservative treatment. We offered clinical and echocardiographical follow-up.

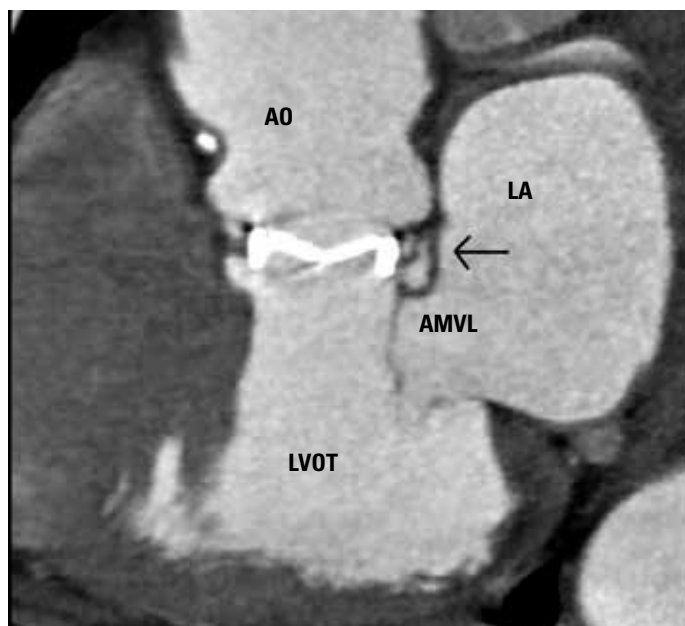
Figure 3. Multislice computed tomography image of a pseudoaneurysm in the mitral-aortic intervalvular fibrosa (arrow)

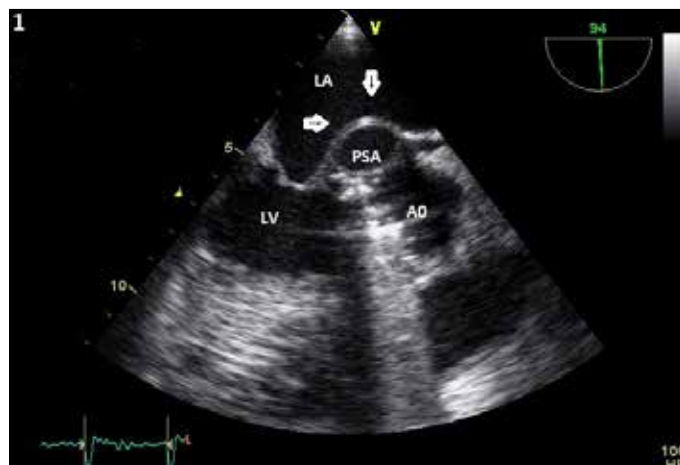
Figure 1. The transesophageal echocardiography image shows a pseudo-aneurysm, bulging from aorta to left atrium (arrows)

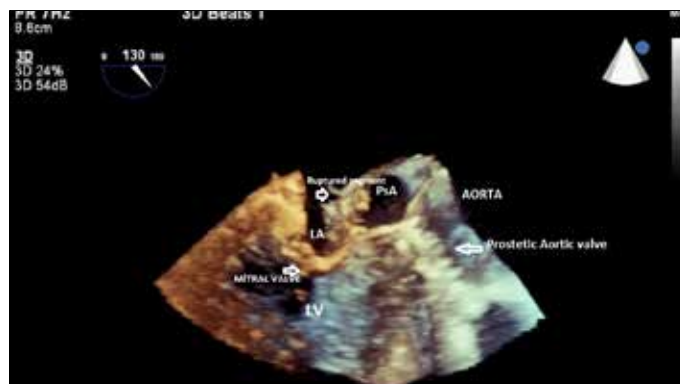
Figure 2. Three-dimensional (3D) transesophageal echocardiography visualization of the ruptured pseudoaneurysm
