## Coexistence of accessory mitral papillary muscle and ventricular septal defect

**Zafer Işılak, Onur Sinan Deveci, Murat Yalçın, Mehmet İncedayı\***  
Departments of Cardiology and \*Radiology, Gülhane Military  
Medical Academy, Haydarpaşa Hospital, İstanbul-Turkey

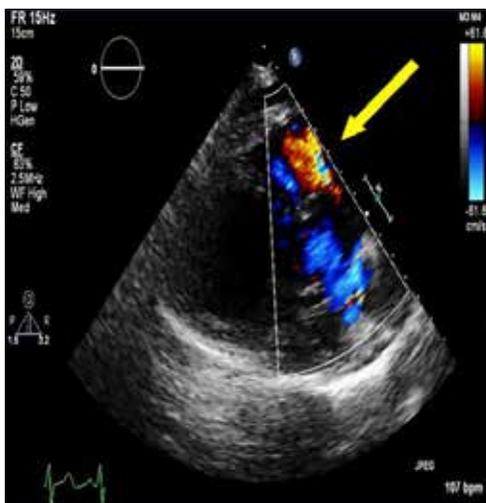
**Figure 1.** TTE in the parasternal long- axis and apical four- chamber views. Color Doppler imaging demonstrating the perimembranous VSD, and two-dimensional echocardiogram showing the accessory papillary muscle across the LVOT

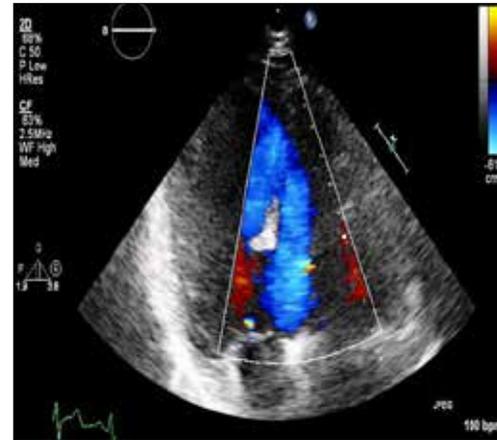
**Figure 2.** TTE in the parasternal long- axis and apical four- chamber views. Color Doppler imaging demonstrating the perimembranous VSD, and two-dimensional echocardiogram showing the accessory papillary muscle across the LVOT

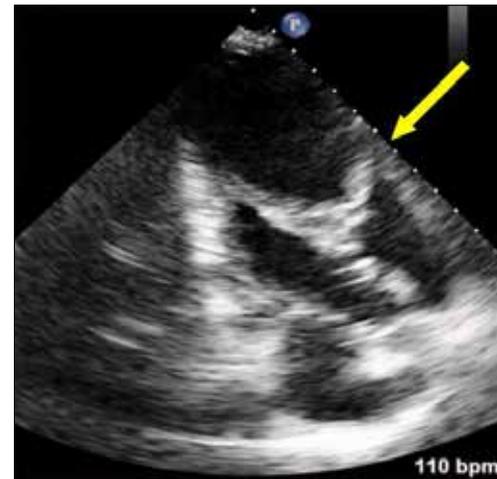
**Figure 3.** TTE in the modified two-chamber view. The accessory papillary muscle originating from the anterolateral papillary muscle is seen

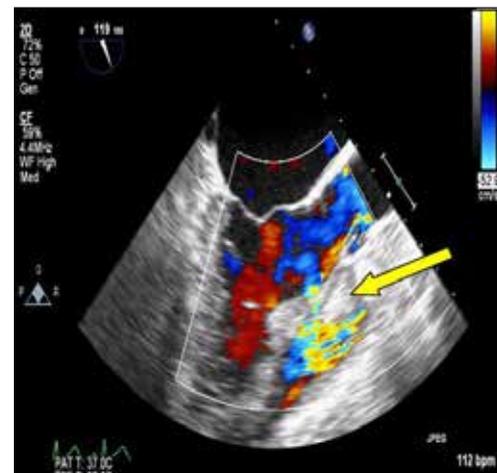
**Figure 4.** TEE demonstrating the perimembranous VSD

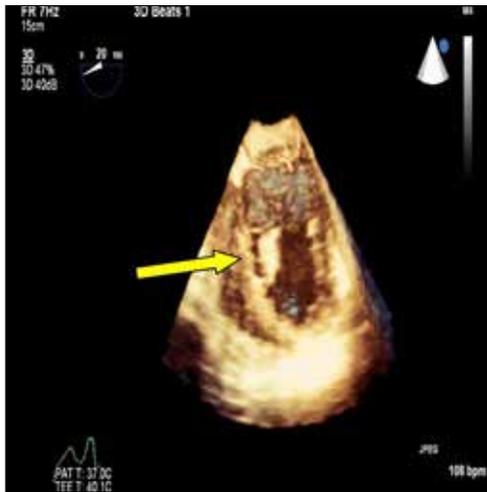
**Figure 5. Real-time three-dimensional TEE demonstrating the accessory papillary muscle extending from the interventricular septum to the LVOT**

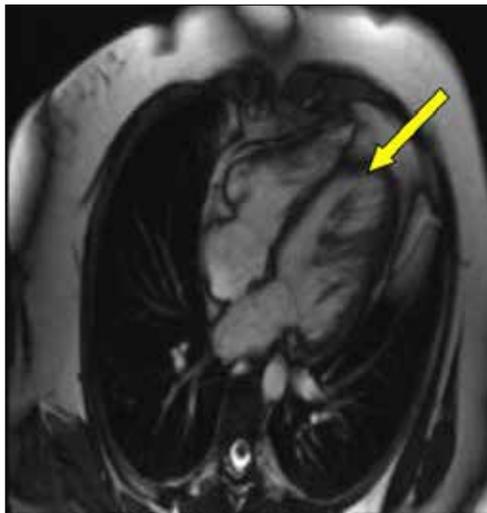
**Figure 6. Cardiac MRI in the vertical axis showing the accessory papillary muscle**

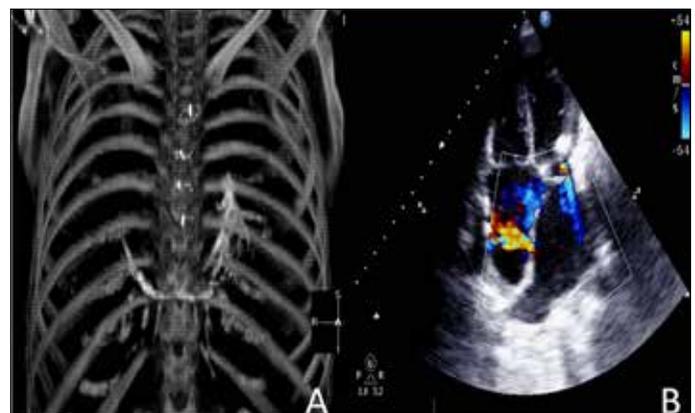
**Figure 1. A) Multislice CT angiogram, three-dimensional bone-window image of pericardial calcification, B) Color Doppler echocardiography showing secundum atrial septal defect**

We present a 31-year-old female with history of constrictive pericarditis operation due to childhood tuberculosis who complained of breathlessness and swelling (Fig. 1A). We diagnosed secundum atrial septal defect (ASD) and dilated coronary sinus (CS) in her control echocardiography (Fig. 1B). Contrast echocardiography via left brachial venous injection revealed persistent left superior vena cava (PLSVC). To evaluate the heart and the pericardium, contrast enhanced multislice computerized tomography was performed via left brachial venous injection. Volume rendered images showed PLSVC and hemiazygos vein anomalous drainage to CS were diagnosed (Fig. 2A, B). There were no abnormal shunts from PLSVC and hemiazygos vein to other cardiac areas. Vena cava inferior (VCI) was right-sided and draining to
