A challenging image during pacemaker implantation 🚳

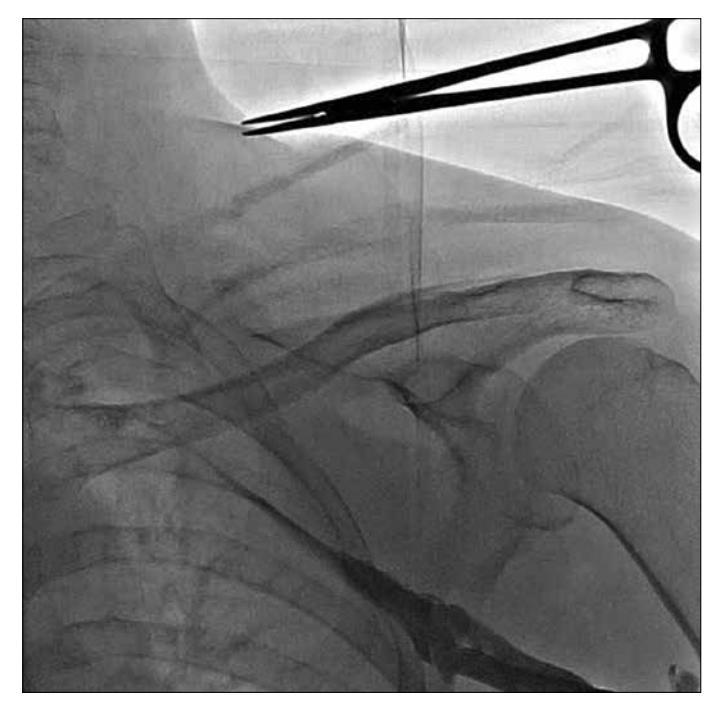
Figure 1. Venography after initial unsuccessful attempts

A 60-year-old female patient was admitted to our hospital with the complaints of syncope and palpitation. She had undergone coronary artery bypass graft surgery 2 years previously and was not taking any medications at the time of presentation. Her electrocardiography on admission was in normal sinus rhythm. Twenty-four-hour Holter monitoring revealed frequent pauses up to 5 seconds with paroxysmal bradycardia and tachycardia episodes. Coronary angiography showed that all coronary grafts (left internal mammarian artery-left anterior descending artery, saphenous vein-right coronary artery) were patent. In view of the Holter findings and the patient's symptoms, a dualchamber pacemaker implantation was planned. Before the procedure, the patient was well hydrated, and the left subclavian vein was chosen for implantation. Because multiple attempts to puncture the subclavian vein were unsuccessful, a venography was performed and revealed a challenging image (Fig. 1, Video 1). Despite incremental doses of nitroglycerin via the ipsi-

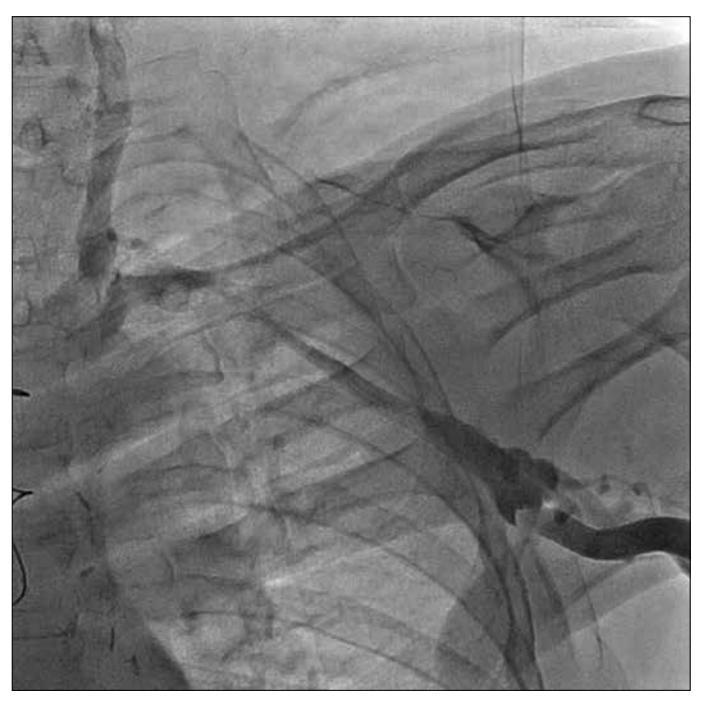
Figure 2. Venography after nitroglycerin application

lateral peripheral vein, this image did not change (Fig. 2, Video 2). A last attempt by a lateral approach was than successful with cannulation of the subclavian vein, but there was no good flashback. However, a hydrophilic guidewire was tried, and it was successfully passed through this segment without difficulty. A dual-chamber pacemaker was implanted with no post-procedural event.
