An unusual image of Vieussens' arterial ring communicating with the pulmonary artery

Bicuspid aortic valve and extremely elongated chordae tendineae protruding into the left ventricular outflow tract

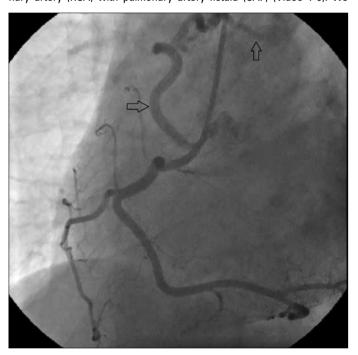
Figure 2. Right coronary angiography demonstrated the dilated conus branch with pulmonary artery fistula (arrow)

A 58 year-old male patient with a history of smoking and positive family history was admitted to our clinic complaining of chest pain. Because of the positive exercise stress test, coronary angiography was performed. His coronary angiography revealed noncritical lesions, but visualized VAR between left anterior descending artery (LAD) (Fig. 1-4) and right coronary artery (RCA) with pulmonary artery fistula (CAF) (Video 1-6). We

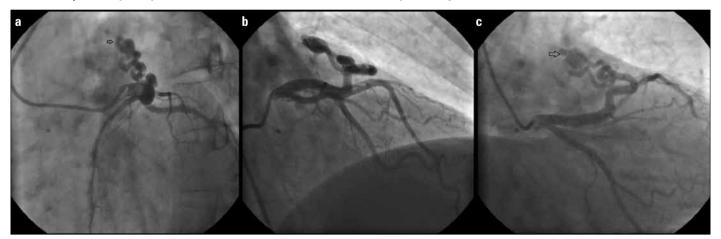
Figure 3. a, b. Vieussens arterial ring, pulmonary artery fistula, and aneurysm of ring (arrows)

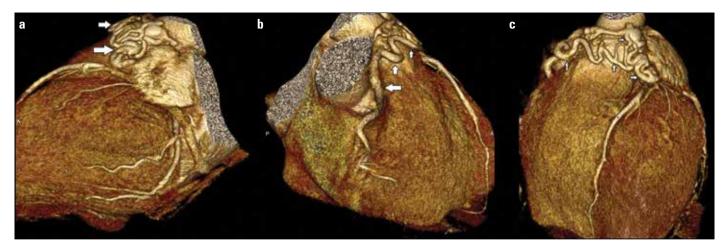
Figure 4. a-c. Three-dimensional reconstruction of computed tomography coronary angiography. The right conal branch and the proximal left anterior descending coronary artery formed Vieussens' arterial ring (arrow) with aneurysmal dilatation

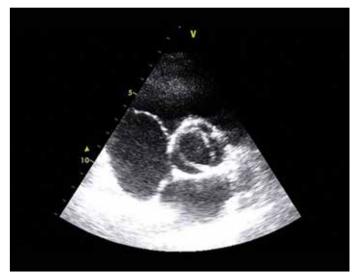
Figure 1. Parasternal short-axis view at aortic level showing a bicuspid aortic valve

A 32-year-old man was admitted to our hospital with atypical chest pain. Clinical examination revealed a grade 2 systolic murmur in the aortic area. His electrocardiogram and chest X-ray were normal. Transthoracic echocardiography showed a bicuspid aortic valve with mild aortic regurgitation and an extremely elongated anterior mitral chordae tendineae protruding into the left ventricular outflow tract (LVOT) during systole, which was not associated with mitral valve prolapse or significant mitral regurgitation (Fig. 1-3, Video 1, 2). Doppler examination demonstrated no significant pressure gradient across LVOT at rest and during Valsalva maneuver. Transesophageal echocardiography (TOE) was planned but not performed because the patient refused any further evaluation.
