## Mechanical prosthetic aortic valve dehiscence presenting as sudden cardiac death due to extrinsic compression of the left main coronary artery

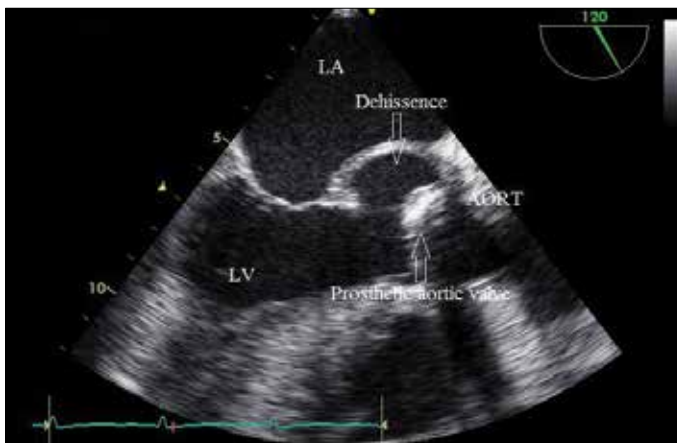
**Figure 1. Long-axis aortic TEE view: aortic valve dehiscence**  
 LA - left atrium; LV - left ventricle; TEE - transesophageal echocardiography

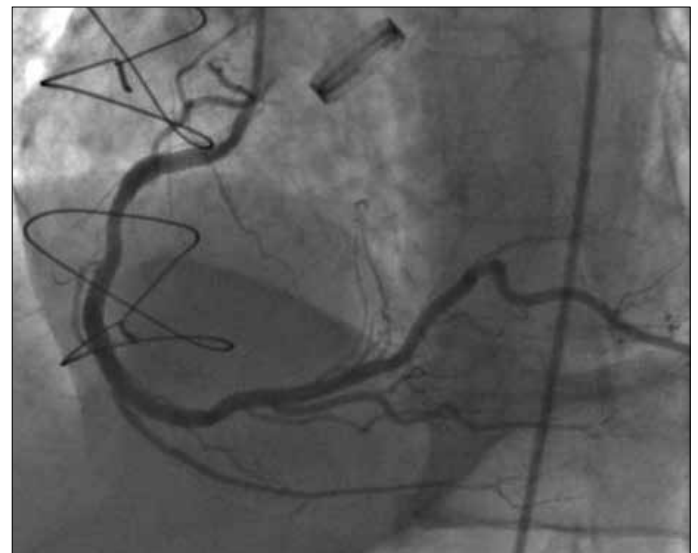
**Figure 3. Normal angiography of the RCA**
